**Kontzamanis Graumann  
Smith MacMillan Inc.**  
Suite 102 - 4561 Parliament Ave  
Regina, SK S4W 0G3

Re: Normanview Mall Light Pole Foundation Assessment

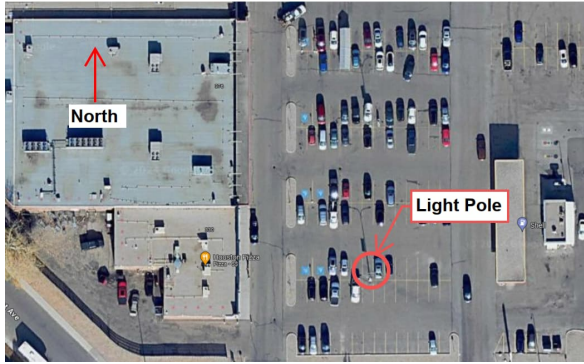
Photo 1: Light Pole Location

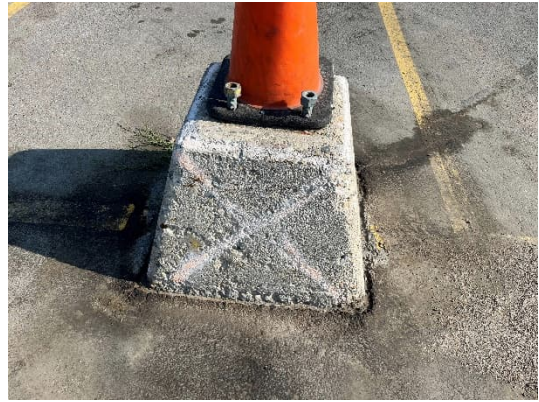
The remaining three anchor rods were not damaged and are in good condition. The concrete around all anchor rods does not exhibit any signs of localized damage so no concrete repair is required.

Photo 2: Light Pole Foundation

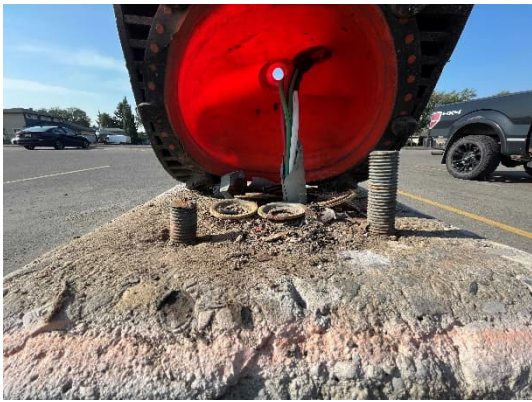
The light pole foundation does not exhibit any significant cracks or spalling of the concrete, indicating that the structural integrity of the reinforced concrete remains in good condition. However, one of the four anchor rods has been sheared off at 1 inch from the top of the concrete, and the remaining extension of this anchor rod is slightly bent. The remaining anchor rod does not exhibit any fracture or stress cracks; therefore, it is still usable after repair. The sheared anchor rod does not provide sufficient thread for the bolt connection to the light pole. Therefore, repair of the damaged anchor rod is required.

Photo 3: Sheared anchor rod

A common method for anchor rod repair involves cutting or drilling another hole in the concrete foundation and installing a drilled-in epoxy type anchor rod. However, due to the close spacing of the existing anchor rods, this approach is not viable in this case. Therefore, it is recommended to repair the sheared anchor rod by extending it. If the base plate's bolt pattern of the new light pole does not align with the existing anchor rod pattern, it is also recommended to modify the base plate accordingly.

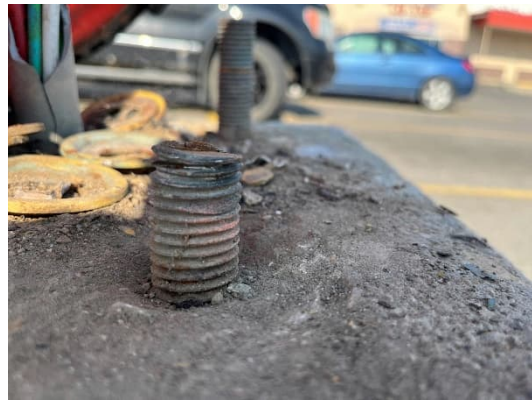
Photo 4: Bent anchor rod
